**RESEARCH REPORT
RESULTS OF TESTS ON A
FRACTURING/CEMENTING TRAILER FRAME**

Engineering Department
Halliburton Services
Duncan, Oklahoma

Report No. FSEL/HALLIBURTON 85-01

December 1985

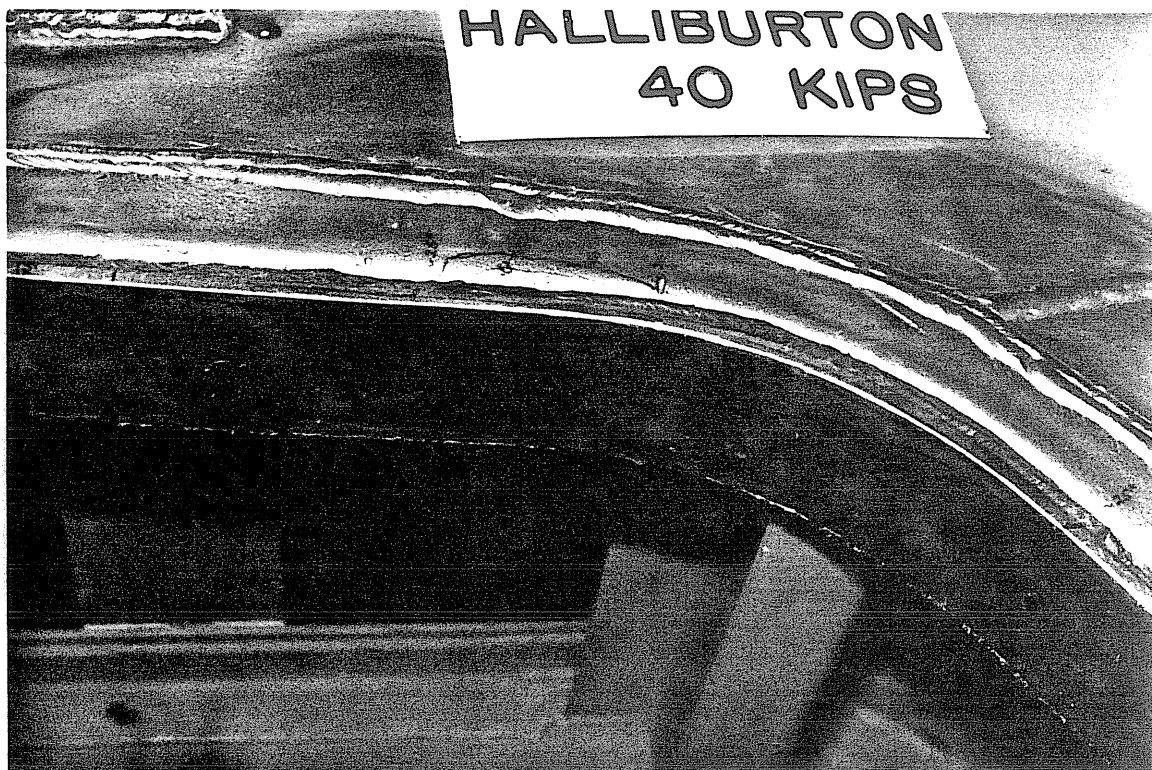
Figure 3.1 Istostrain Lines in the Brittle Lacquer Coating

next, the coating on the specimen was inspected for cracks which would indicate areas where the strain exceeded 1100×10^{-6} inches/inch. The first cracks in the lacquer were observed at a load of 25 kips. These cracks occurred on the outside bottom edge of the lower flange cover plate for a distance of approximately 14 inches along the portion of the flange which is concave downward. After these initial cracks were observed, additional loading increments were applied to obtain crack patterns for total loads of 30, 35, and 40 kips. At each of these increments, an outline of the cracked region of the coating was drawn on the specimen. These iso-strain lines can be seen in Fig. 3.1.

The distribution of stresses in the lower flange of the curved portion of the beams can be seen in both the brittle lacquer analysis and static test results. The brittle lacquer analysis indicated that the lower flange next to the beam web reached approximately 1100 microstrain at a load of 25 kips. The test was continued to a load of 40 kips, but the region of the flange which had a strain exceeding 1100 microstrain only extended about halfway across the flange, indicating that the toe of the flange was much less than fully effective.

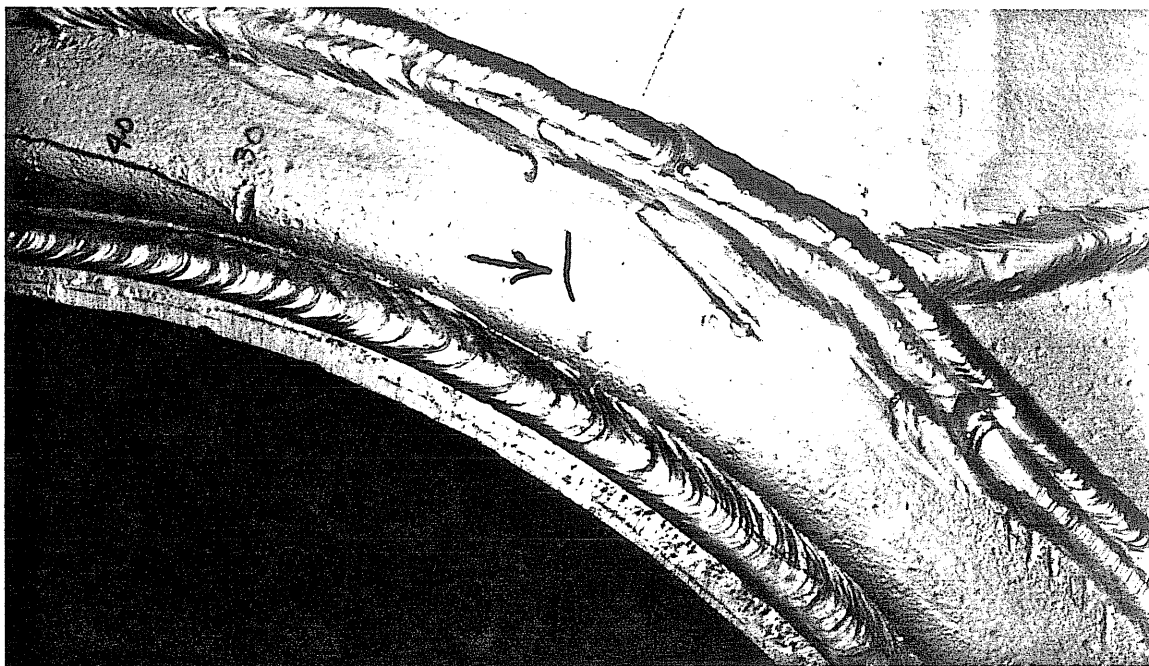
Figure 3.2 Location of First Crack

The first crack was noticed in the inside surface of the web of the driver's side beam at approximately 50,000 cycles. This crack initiated at the toe of the bottom flange of the crossmember in the curved region of the beam as shown in Fig. 3.2. This cracking was probably accelerated by an undercut into the web from the adjacent weld. Another contributing factor was the large out-of-plane strains present at this location due to the restraining effects of the crossmember on the beam flange rolling.

Testing was continued to determine how fast the crack would grow. The crack was noticed to have penetrated the beam web at 98,000 cycles. At this time two Halliburton employees, Bill Dennison and Steve Parker, brought a welder to repair the frame. While Bill and Steve were at Fears lab the frame was cycled approximately 2000 cycles to demonstrate the opening of the crack and the rolling of the beam flanges, bringing the total cycle count to 100,000 at the time of the first repair.

The frame was modified by cutting away the bottom 3.5 inches of the crossmember to reduce the stress concentrations in the beam web due to the restraint of the beam flange rolling. The crack in the driver's side beam was then repaired by welding along the crack on the inside of the web as shown in Fig. 3.3, grinding through the crack from the outside of the web down into the weld, and then filling the root left from grinding with weld.

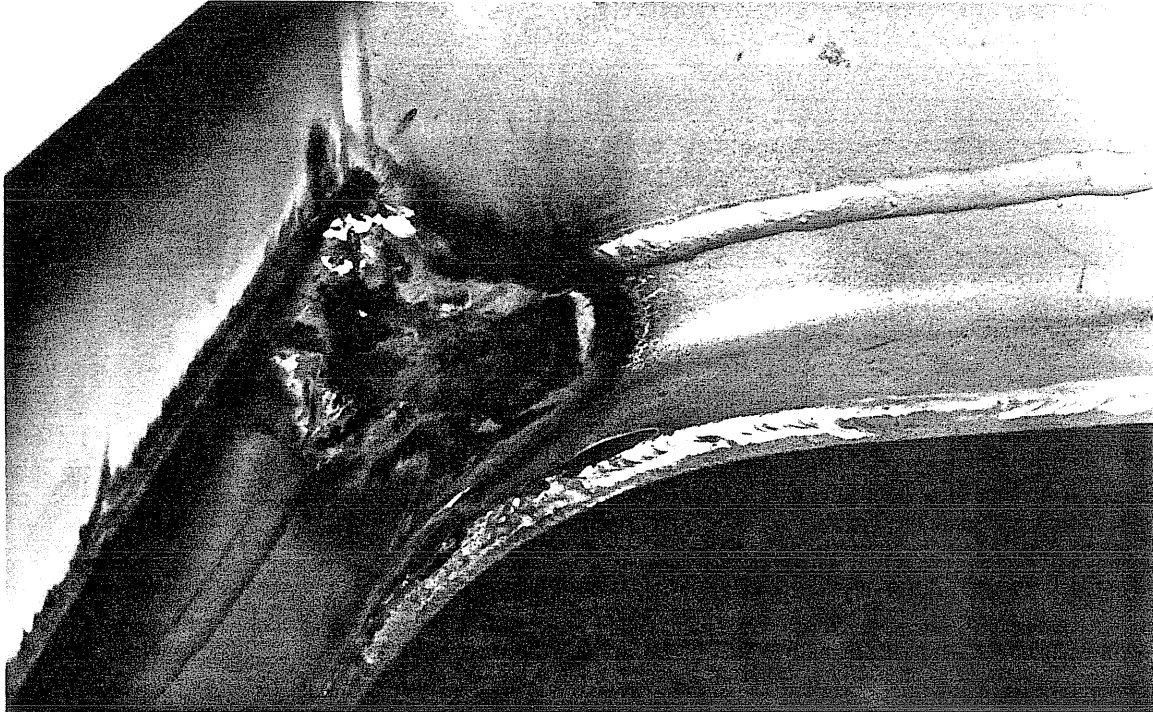
Figure 3.3 Repair Weld on Inside Surface of Beam Web

Three items were noticed by the Halliburton personnel during the repair operation. One was that the lower flanges of the curved beams were being held apart by the lower portion of the crossmember which was removed. This restraint required that the portion of the crossmember be driven from between the beams with a hammer after it had been cut loose. The second item noticed was that heat generated during the crossmember modification caused the crack in the beam to open up and become more easily visible. The resulting crack can be seen at the left of the discolored area in Fig. 3.4. The third item reported was a discrepancy between the dimensions of the driver's and passenger's side beams which resulted in a shallower section in the curved portion of the driver's side beam.

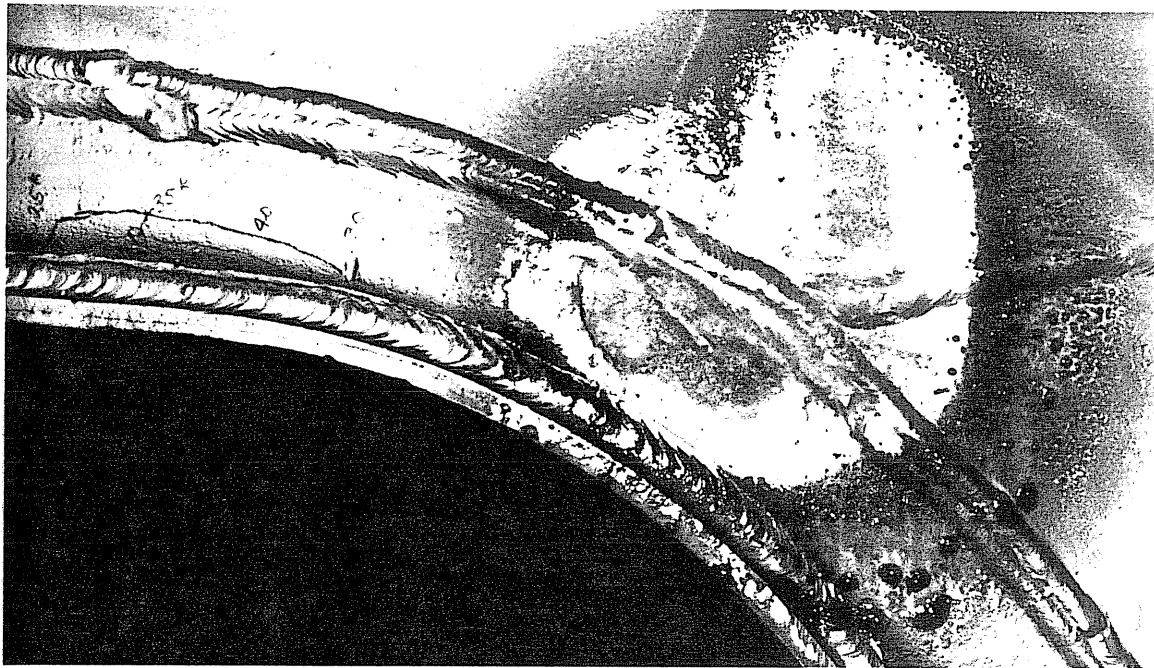
Figure 3.4 First Crack after Removal of Crossmember

After the repair was completed, fatigue testing was continued at a total count of 100,000 cycles. At 124,000 cycles, a small crack was noticed in the passenger's side

beam at the same location as the one repaired in the driver's side beam. It is likely that this crack had initiated before the crossmember was modified at 100,000 cycles, as this location was subjected to large strains before the modification. Other factors which encouraged the formation of this crack were the heat affected zone from the welding to the crossmember and the heat applied to the region during the modification. This crack was approximately 0.5" long when first noticed and could be seen only on the inside surface of the beam web. At 174,000 cycles, the crack in the passenger's side beam had grown to a length of 1.4" on the inside face of the beam, but could not be seen on the outside surface of the beam. This crack lengthened to 1.6" when the total count was 192,000 cycles, but still not be seen on the outside of the web. An inspection with dye penetrant at 200,000 cycles revealed that the crack had penetrated the web and grown to a length of 1" on the outside of the web.

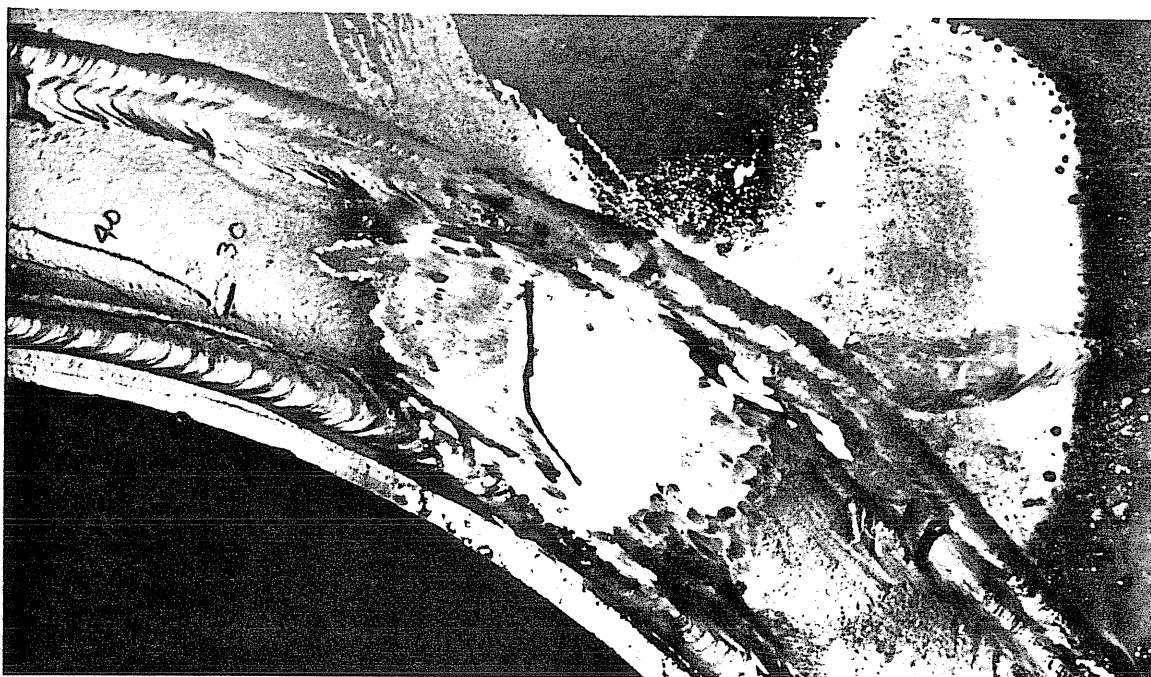
Figure 3.5 Location of Second Crack

The curved beam on the driver's side was observed to be cracked just below the previous repair at a total count of 192,000. At this time the crack was 1.4" long on the outside surface of the beam web, having completely penetrated the web. The inspection with dye penetrant performed at 200,000 cycles indicated that the crack had grown to 2". This crack is outlined in red in the heat discolored area of

the beam in Fig. 3.5.

Halliburton personnel repaired these crack in a manner similar to the previous one, by grinding out the crack and filling the resulting groves with weld. This was accomplished at a total count of 200,000 cycles.

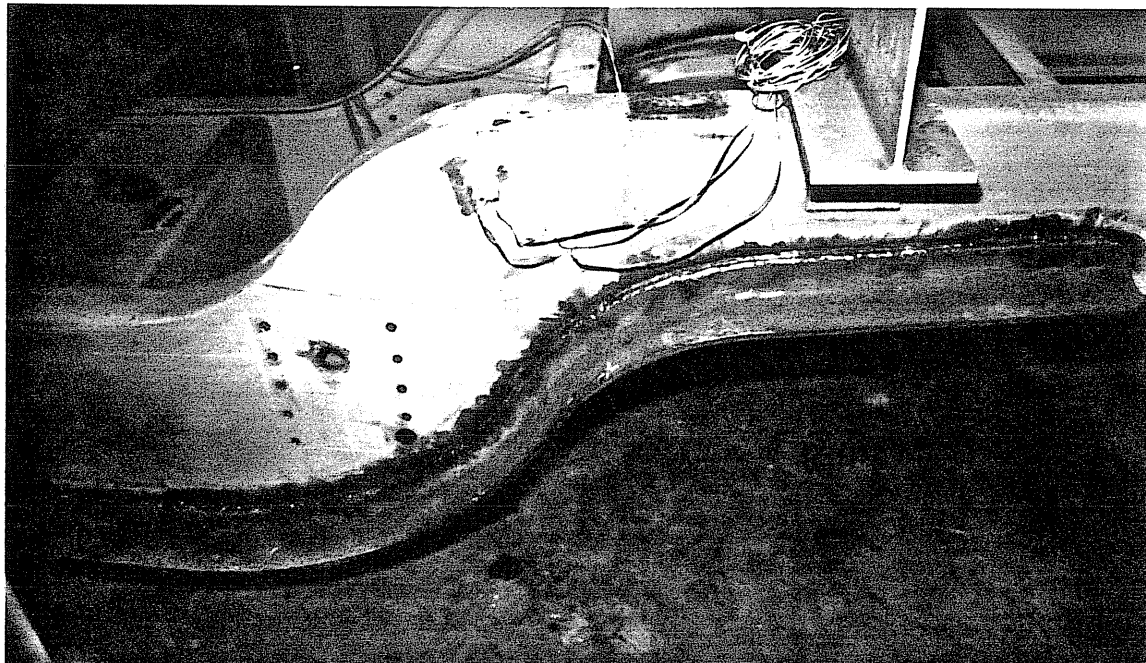
Figure 3.6 Reinforcing Angles added to Specimen

welding to the cover plate of the existing flange. This method of reinforcement was used to reduce stresses in the web by two mechanisms. The first mechanism is the reduction of in-plane stresses in the web due to the increased section modulus and moment of inertia of the beam. The second mechanism is the reduction of out-of-plane stresses in the web due to flange rolling caused by the unsymmetric lower flange. By creating a flange which is more symmetric with respect to the web, the rolling tendencies of the two projecting legs will cancel, reducing the out-of-plane forces applied to the web.

At a count of 290,800 cycles, a crack was noted in the passenger's side beam. This crack occurred in the repaired region and was 2" long. Fatigue testing was terminated at this point due to the consistent reoccurrence of cracks in the repaired regions.

The curved region of each beam was then reinforced by the addition of a bent angle opposite to the lower flange as shown in Fig. 3.6. These angles were welded to the beam webs along the toe of their vertical leg only, to avoid

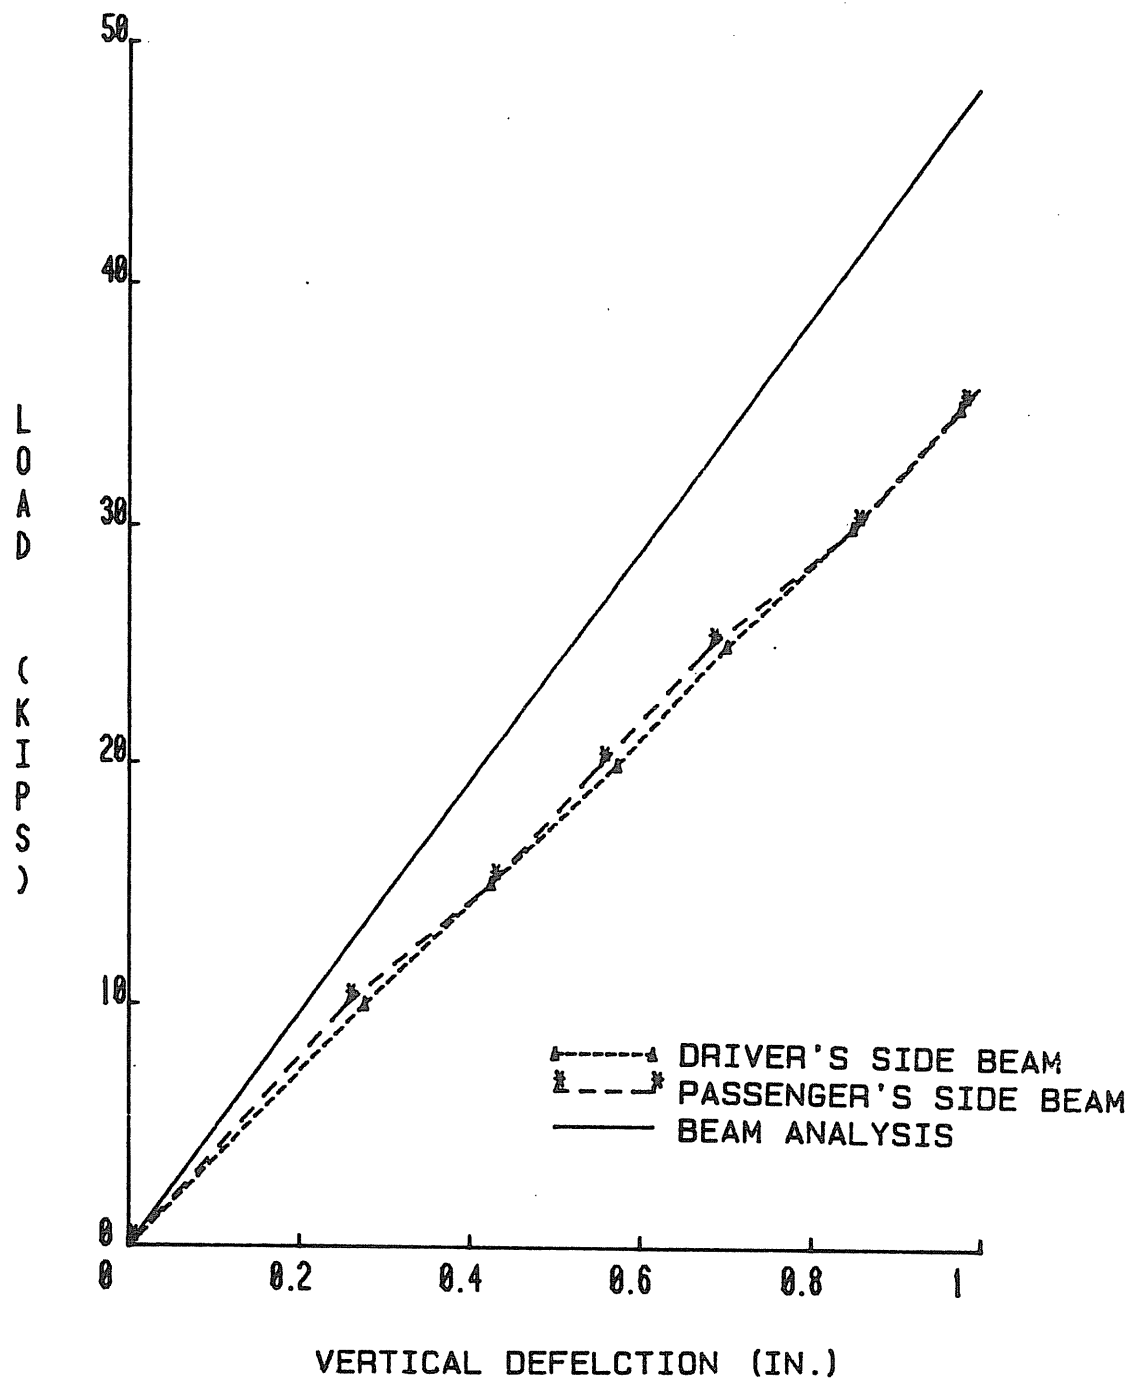
Figure B.33

The relationship between applied load and beam deflection at the wire potentiometers was predicted using a plane-frame stiffness analysis program. This prediction is shown as the solid line in Fig. B.33 of Appendix B. In this figure it can be seen that the predicted stiffness of the frame was significantly greater than actual. The most important reason for this over estimation of the frame stiffness is that the analysis failed to account for the tendency of the flanges in the curved region of the beam to "roll", reducing the stress in the flange at locations away from the web. This reduced flange effectiveness resulted in a

smaller effective moment of inertia for curved region of the beams which caused the reduced stiffness of the frame.
