RESEARCH REPORT
RESULTS OF TEST ON A MODIFIED
FRACTURING/CEMENTING TRAILER FRAME

Halliburton Services
Duncan, Oklahoma

Report No. FSEL/HALLIBURTON 86-01

FEARS STRUCTURAL ENGINEERING LABORATORY
School of Civil Engineering and Environmental Science
University of Oklahoma
Norman, Oklahoma 73019

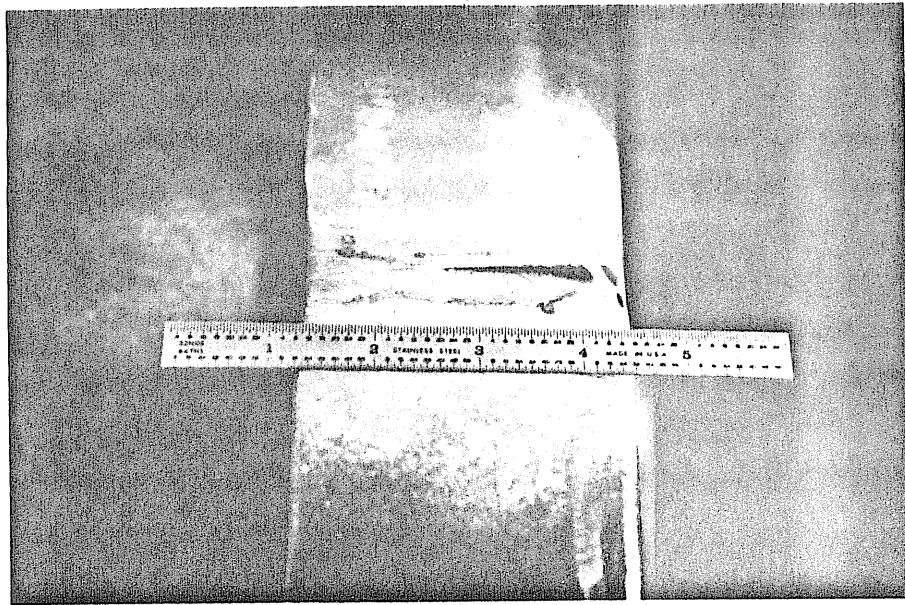
Prior to testing, cracks were discovered by laboratory personnel in the welds splicing the top flanges of the

curved section to the top flanges of the straight beam section. This location corresponds to section 9 of Figure 2.2 and is located 124 inches from the front of the trailer frame. Fig. 2.3 shows one of these cracks. Halliburton personnel were sent to inspect and repair the cracked welds. Upon examination, it was deemed necessary that the welds joining the formed top flanges to the web of the curved beam portion of both beams also be repaired. All defective welds were subsequently gouged out, ground smooth, and new weld material deposited. Fig. 2.4 shows the repair operation in progress. The repair was successful as none of these welds failed during the testing program.

Figure 2.3 Location of Cracked Welds

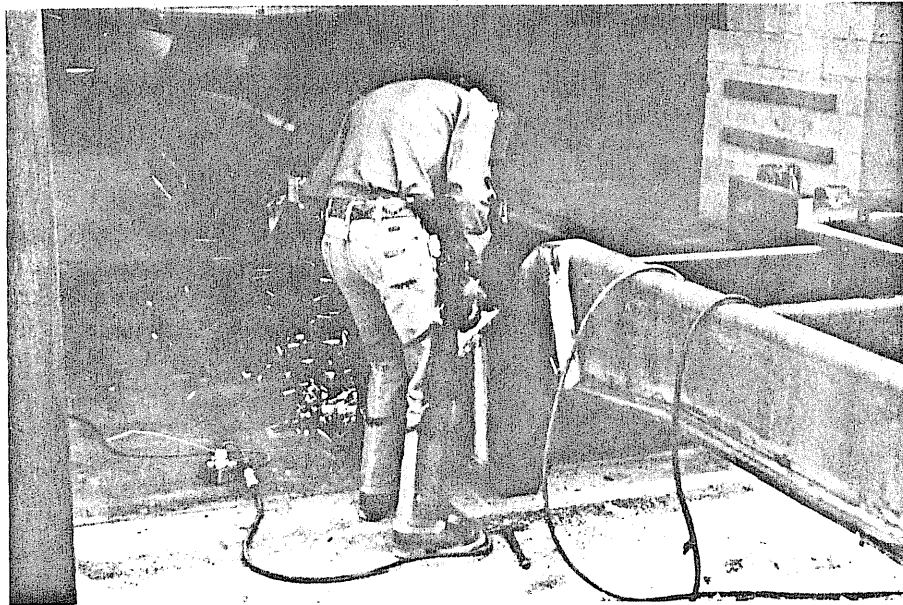
Figure 2.4 Repair of Cracked Welds

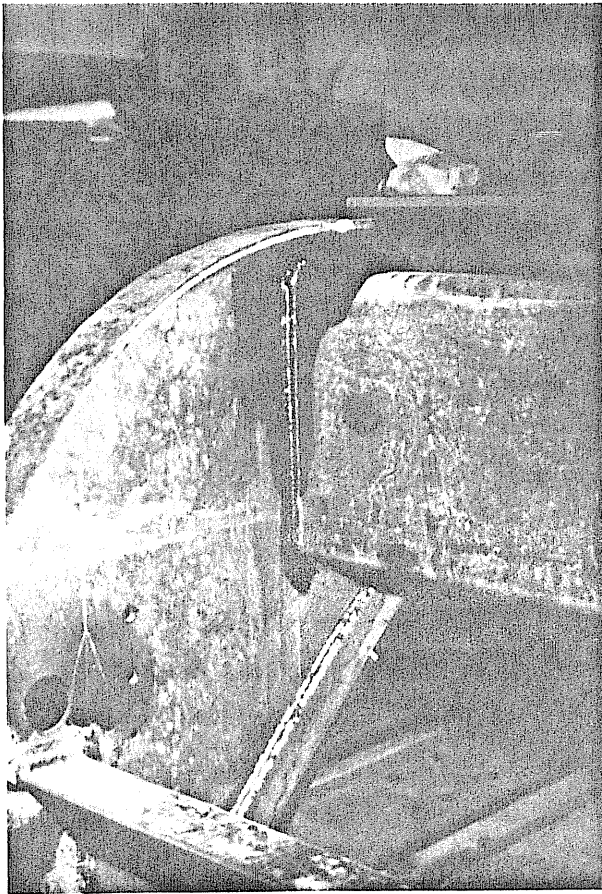
The first crack was noticed at the toe (adjacent to the beam web) of the weld joining the crossmember to the driver's side beam web as shown in Fig. 3.1. This crack was first observed at approximately 690,000 cycles. This crack initiated in the curved beam region at the radius of the crossmember where the beam web joins the crossmember upper flange and propagated along the width of the flange. This cracking was probably caused by the large out-of-plane strains due to the restraining effects of the crossmember on beam flange rolling.

The second crack was noticed at approximately 802,000 cycles at the toe (adjacent to the crossmember) of the weld where the first crack was observed. This crack initiated at the radius described previously, but propagated diagonally, along the face of the weld. In addition, the first crack was approximately 0.5 inches shorter than the

Figure 3.1 Location of
Cracking
(Driver's Side
Beam)

width of the crossmember flange, and the separation of the toe of the weld from the beam web was becoming easily defined without the aid of magnification.

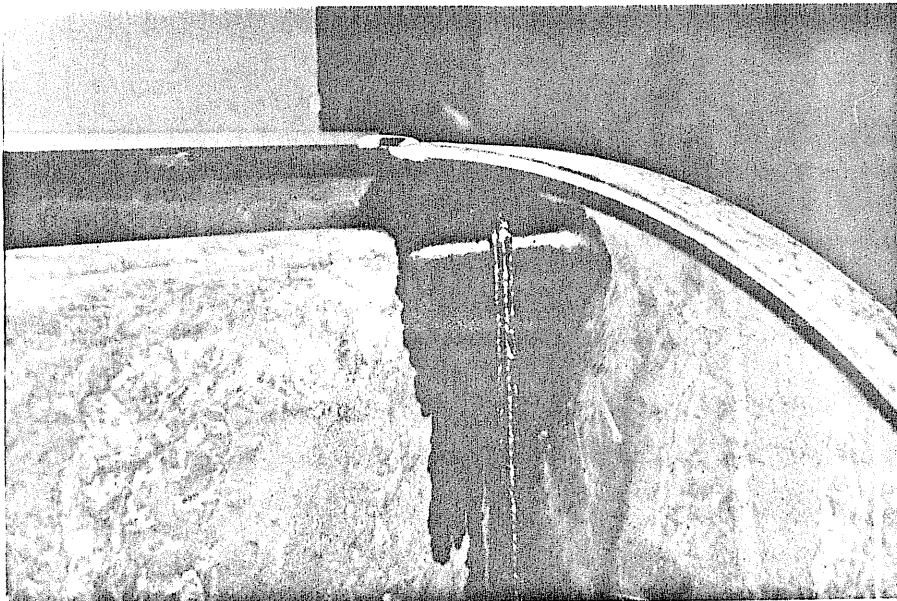
Figure 3.2 Location of Cracking (Passenger's Side Beam)

The third crack was noticed at the toe (adjacent to the web) of the weld joining the crossmember to the passenger's side beam web. This crack was first observed at 802,000 cycles. This small crack initiated at the radius (similar to that described previously). Figure 3.2 shows the location of cracking.

The fourth crack was noticed occurring in the same proximity of the third crack at approximately 840,000 cycles. This crack initiated near the same point where the third crack initiated, but propagated diagonally away from the weld (and) into the web to a length of approximately 0.25 inches. Cracking was limited to the inside surface of the beam web only.

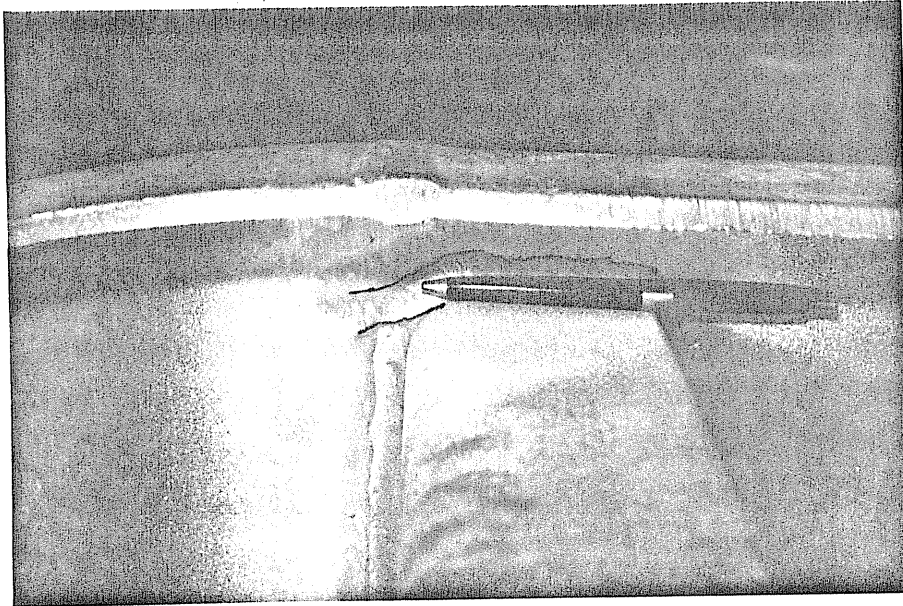
The fifth and sixth cracks were noticed in the driver's side beam web at approximately 930,000 cycles. The fifth crack initiated at the radius (described previously), and propagated diagonally away from the weld and into the beam web to a length of 0.5 inches but was restricted to the inside surface of the beam web only. The sixth crack initiated approximately 1 inch below the fifth crack and

propagated parallel to the same, and into the beam web to a length of approximately 0.25 inches. Cracking was restricted to the inside surface of the beam web. In addition, the first crack was equal in length to the crossmember flange width and the separation between the weld and beam web was readily visible.

Fatigue testing was terminated at a count of 1,000,000 cycles, which was the criteria defined for this test. A cleaning solution was applied to the cracked areas and wiped clean. Next, a dye penetrant was applied for five minutes to be absorbed into the cracks. The excess dye penetrant was wiped away and a developer was applied. The specimen was then loaded to 46.1 kips (twice the service load), and a photographic record was made. Figures 3.3 and 3.4 show the cracks on the driver's side and passenger's side beam, respectively.

Figure 3.3 Cracks Located on Driver's Side Beam

primarily caused by the "rolling" of the top curved flange. If additional improvements in fatigue life are needed, reductions in the amount of "rolling" in the top curved flange should be attempted, either by direct braces to the top flange, manufacture of a symmetric top flange, or other methods.

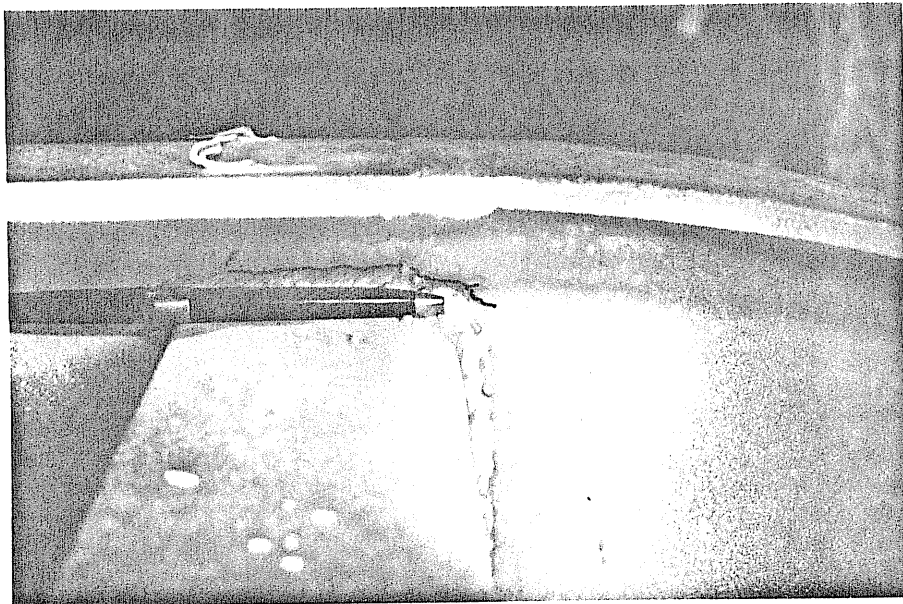
The seventh crack was noticed in the inside surface of the passenger's side beam web at approximately 940,000 cycles. This crack initiated at the toe (adjacent to the beam web) of the weld joining the crossmember to the passenger's side beam web approximately 0.25 inches below the third crack and propagated parallel to the same into the beam web to a length of 0.25 inches.

Figure 3.4 Cracks Located on Passenger's Side Beam

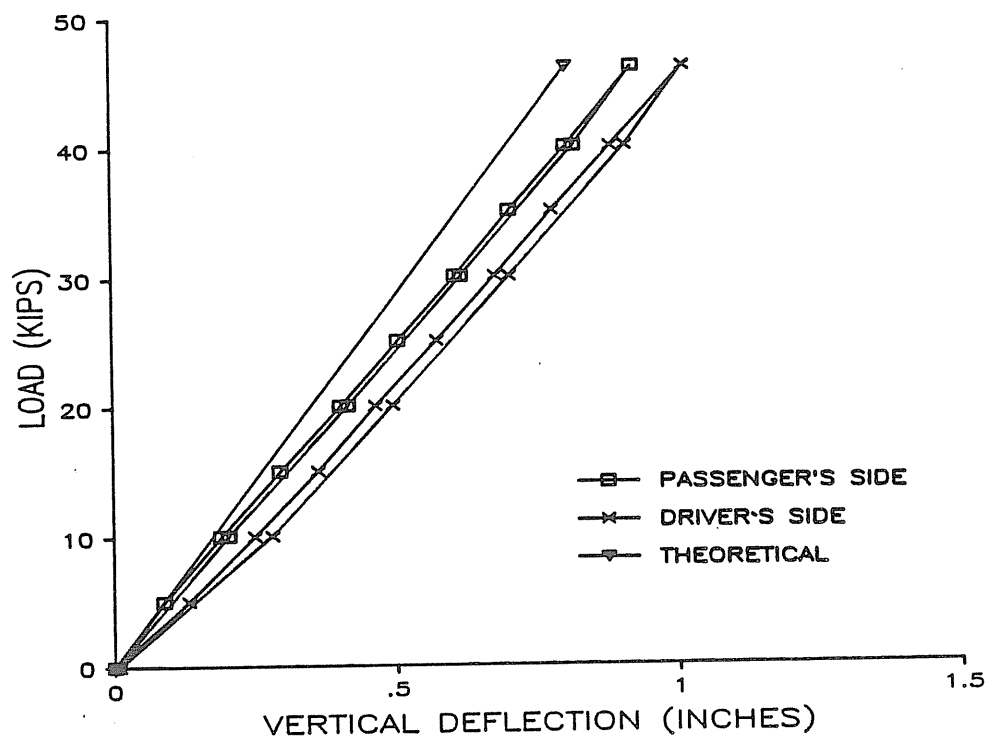
Figure B.3

The relationships between applied load and beam deflection at the wire potentiometers was predicted using a plane frame stiffness analysis program. This prediction is shown in Fig. B.3 of Appendix B. In this figure it can be seen that the predicted stiffness of the frame was greater than actual. The most important reason for this overestimation of the frame stiffness is that the analysis failed to account for the tendency of the flanges in the curved beam region to "roll", reducing the stress in the flange at locations away from the web. This reduced flange effectiveness resulted in a smaller effective moment of

inertia for the curved region of the beams which caused the reduced stiffness of the frame.
