EXPERIMENTAL INVESTIGATION OF RIGID  
FRAMES INCLUDING KNEE CONNECTION STUDIES  
-FRAME ASSEMBLY TESTS-

Research Report

Report No. FSEL/MESCO 85-01

FEARS STRUCTURAL ENGINEERING LABORATORY  
School of Civil Engineering and Environmental Science  
University of Oklahoma  
Norman, Oklahoma 73019

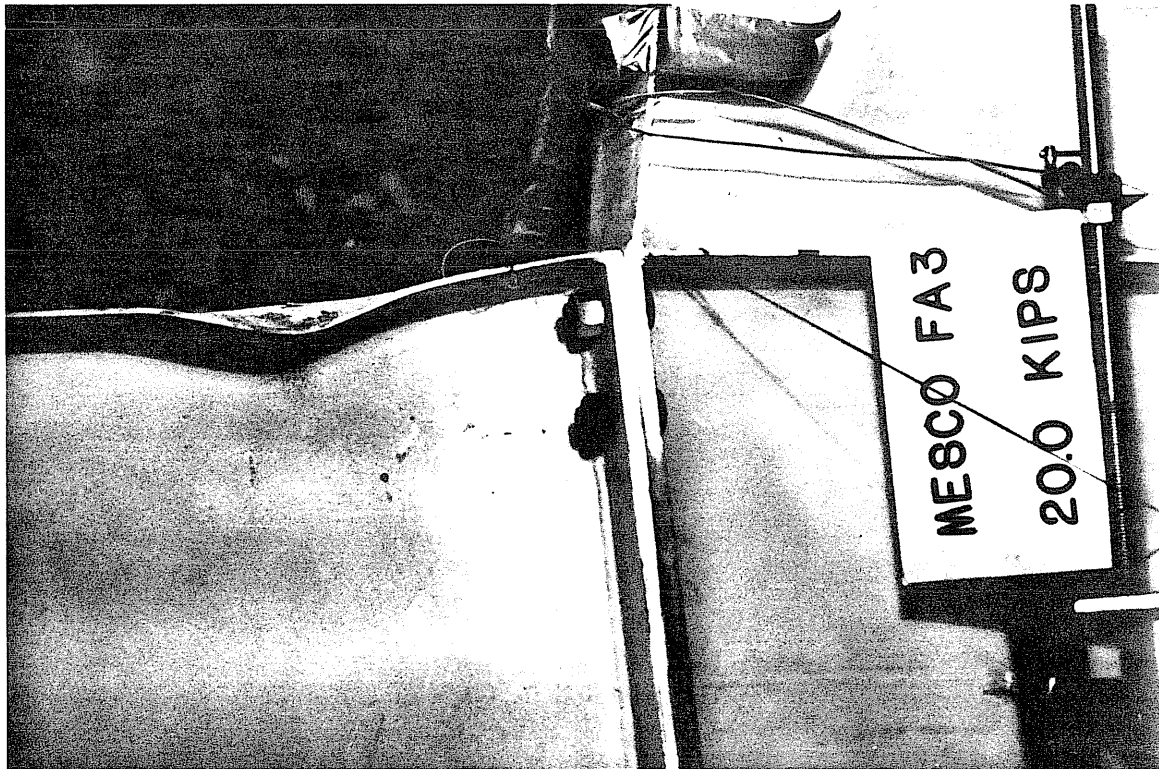
Figure 3.4 Photographs of Test FA-3

b) Local Rafter Flange Buckling

Pertinent parameters for this test are: tapered column and rafter sections; four tension bolt ( $3/4$  in. diameter), flush end-plate (6 in. by  $1/2$  in.) connection; and a nominal 24 in. by 24 in. by 0.186 in. panel zone ( $h/t = 129.0$ ) with a partial stiffener. Photographs of the test are shown in Figure 3.4.

The maximum applied load in this test was 19.8 kips. Failure occurred due to either local torsional plate buckling of the rafter compression flange or panel zone plate buckling. The local flange buckling is shown in Figure 3.3(b). However, Figure C.10 clearly shows significant out-of-plane movement of the center of the panel zone plate. The predicted failure load based on local flange buckling is 26.8 kips and on panel zone plate buckling is 20.8 kips. Thus, panel zone plate buckling is the recorded failure mode.
