**RESEARCH REPORT
RESULTS OF TESTS ON A
FRACTURING/CEMENTING TRAILER FRAME**

Engineering Department
Halliburton Services
Duncan, Oklahoma

Report No. FSEL/HALLIBURTON 85-01

December 1985

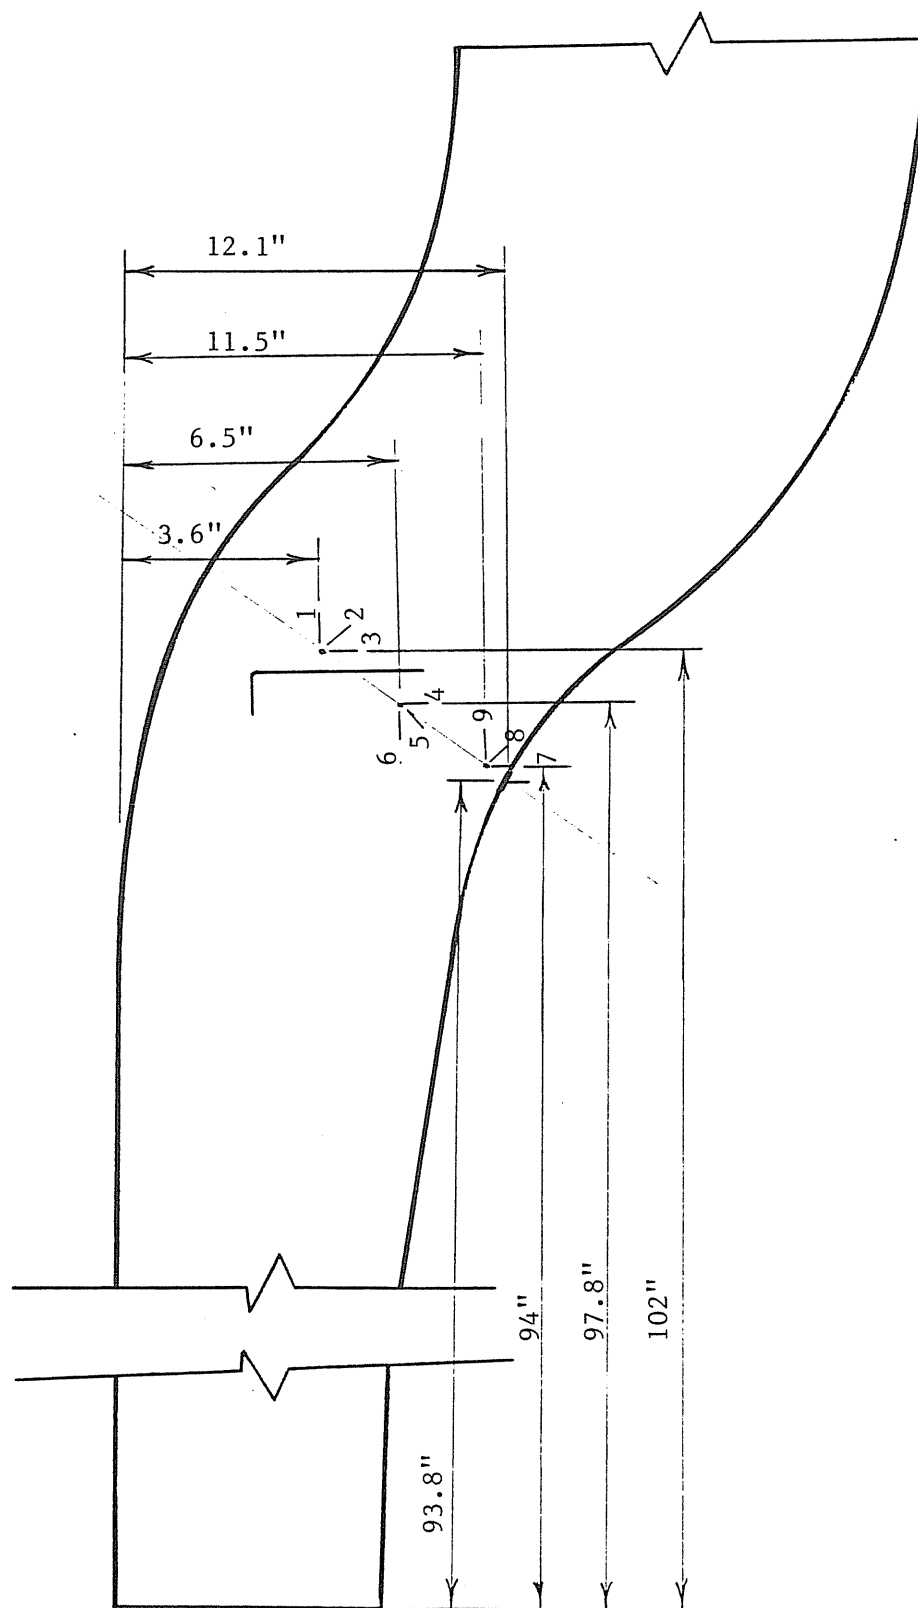
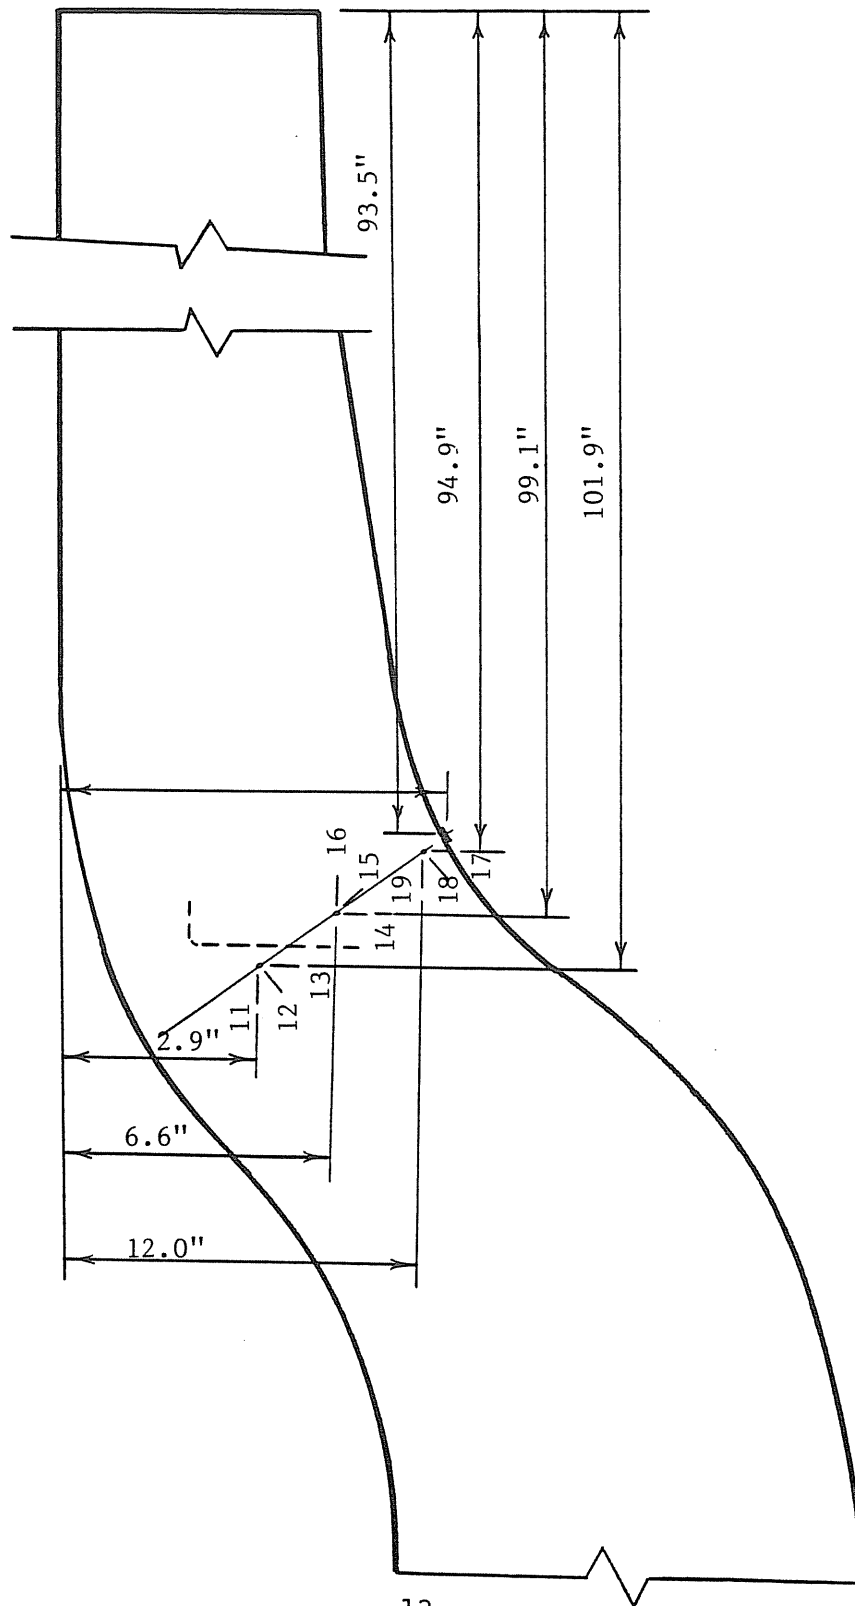
Table 4.2 contains the maximum values of equivalent uniaxial stress calculated for each rosette using the Von Mises yield criterion. The location of the elements of these rosettes were shown previously in Figs. 2.5 and 2.6. The largest equivalent strain in this table occurs at the rosette which consists of gages #17, #18, and #19. This corresponds closely with the location where cracks initiated in the specimen.

in the beam web by reducing the effective cross section properties. A concentrated support to resist rolling was provided to the web by the cross member, resulting in a stress concentration. All cracks initiated in this area.

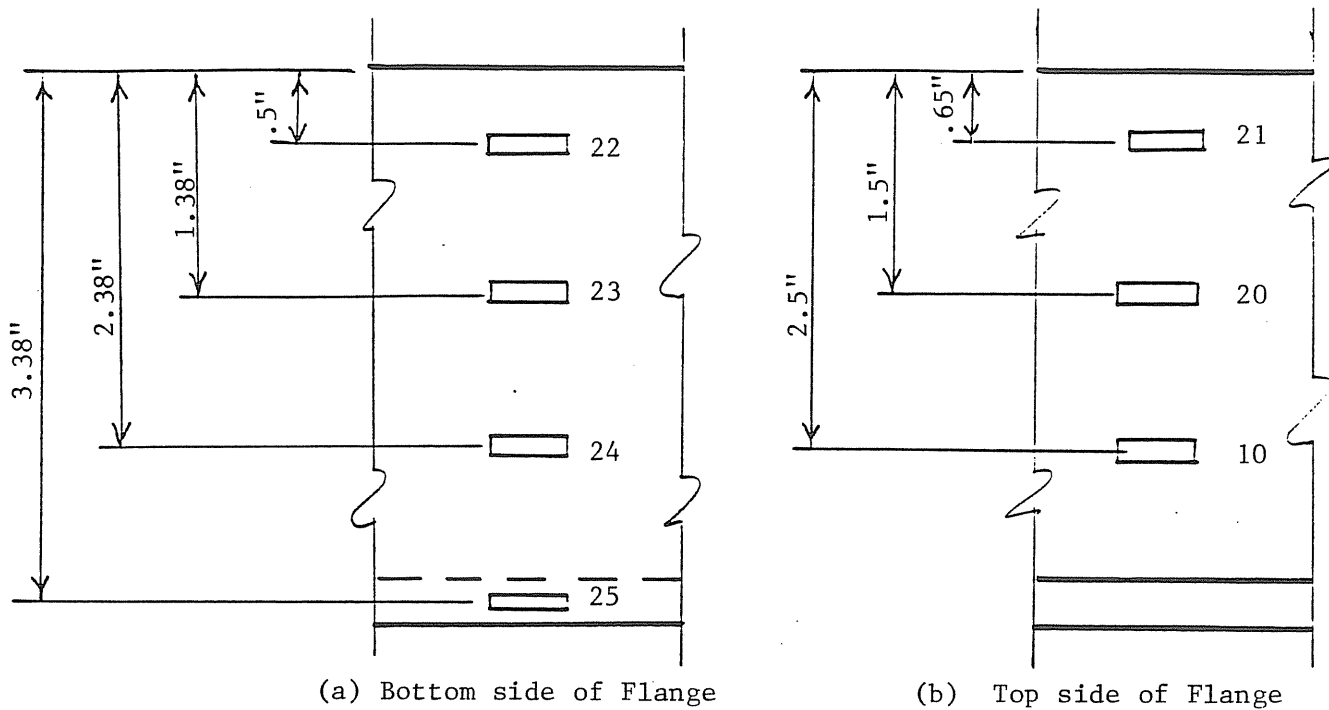
Figure 2.7 Locations of Strain Gages on Beam Lower Flange

Table 4.1 contains the maximum values of stress calculated from the uniaxial strain gages installed on the beam lower flange in the locations shown previously in Fig. 2.7. From this data it can be seen that the maximum stress is largest near the beam web at gage #25 and is smaller at each strain gage located farther from the beam web (at strain

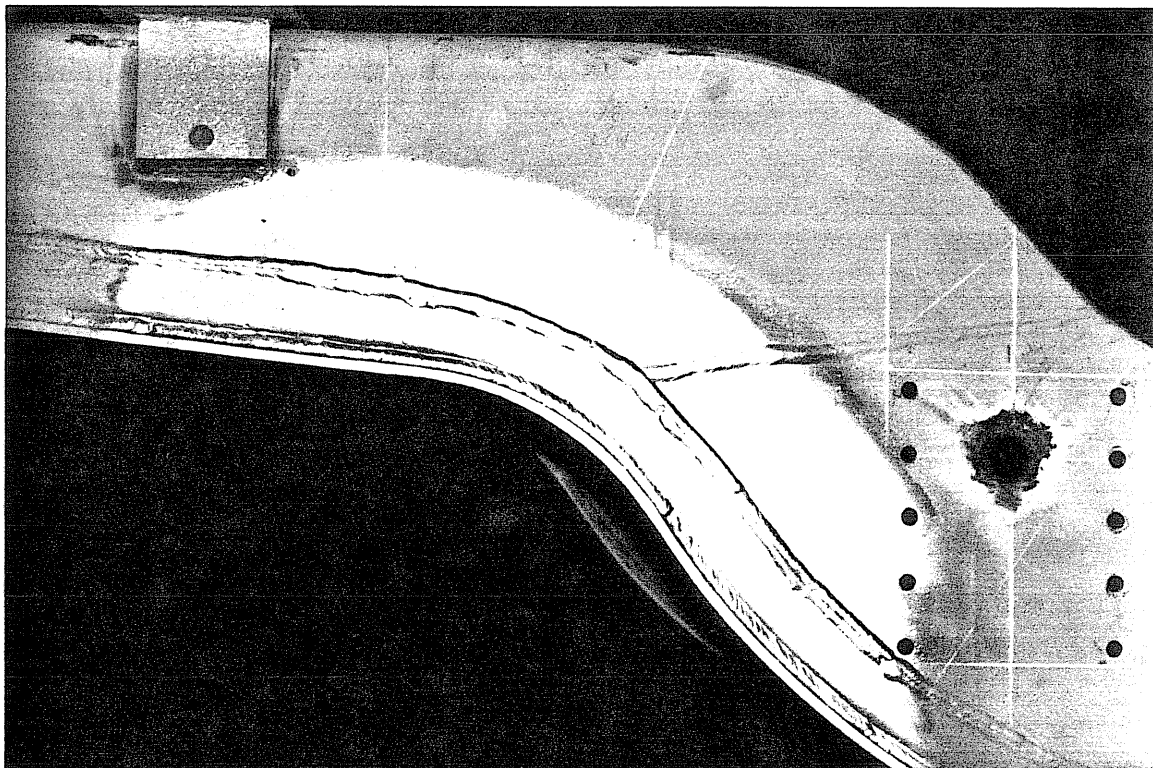
Figure 2.9 Region Analyzed with Brittle Lacquer Coating

The first experimentation on the curved beams was a brittle lacquer analysis. This analysis was conducted on the lower flange and adjacent web in the curved area of the driver's side beam as shown in Fig. 2.9. This area was first sanded to remove any paint and mill scale. Next, the beam area and five calibration bars were coated with a

next, the coating on the specimen was inspected for cracks which would indicate areas where the strain exceeded 1100×10^{-6} inches/inch. The first cracks in the lacquer were observed at a load of 25 kips. These cracks occurred on the outside bottom edge of the lower flange cover plate for a distance of approximately 14 inches along the portion of the flange which is concave downward. After these initial cracks were observed, additional loading increments were applied to obtain crack patterns for total loads of 30, 35, and 40 kips. At each of these increments, an outline of the cracked region of the coating was drawn on the specimen. These iso-strain lines can be seen in Fig. 3.1.
