RESEARCH REPORT
RESULTS OF TEST ON A MODIFIED
FRACTURING/CEMENTING TRAILER FRAME

Halliburton Services
Duncan, Oklahoma

Report No. FSEL/HALLIBURTON 86-01

FEARS STRUCTURAL ENGINEERING LABORATORY
School of Civil Engineering and Environmental Science
University of Oklahoma
Norman, Oklahoma 73019

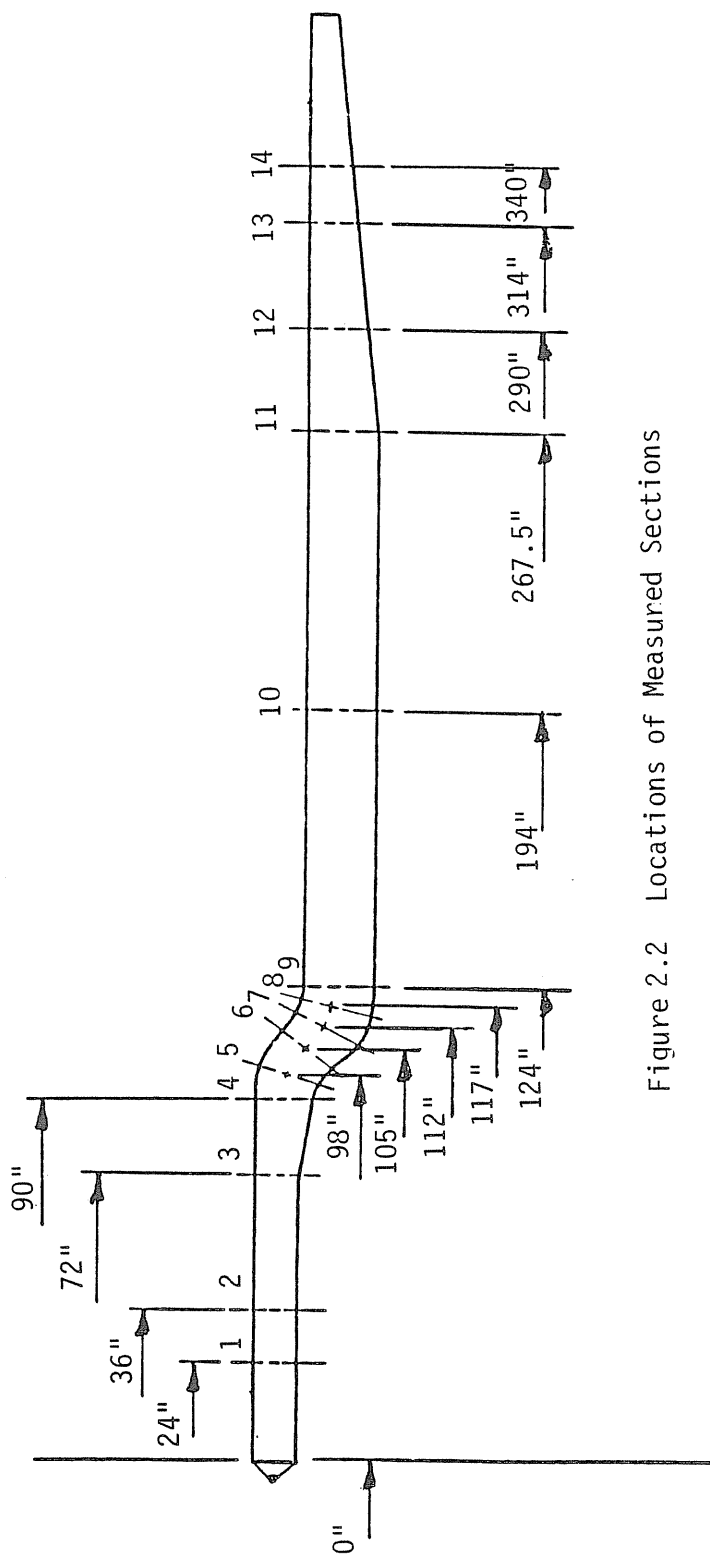
Figure 2.2 Locations of Measured Sections

Prior to testing, cracks were discovered by laboratory personnel in the welds splicing the top flanges of the

curved section to the top flanges of the straight beam section. This location corresponds to section 9 of Figure 2.2 and is located 124 inches from the front of the trailer frame. Fig. 2.3 shows one of these cracks. Halliburton personnel were sent to inspect and repair the cracked welds. Upon examination, it was deemed necessary that the welds joining the formed top flanges to the web of the curved beam portion of both beams also be repaired. All defective welds were subsequently gouged out, ground smooth, and new weld material deposited. Fig. 2.4 shows the repair operation in progress. The repair was successful as none of these welds failed during the testing program.
